TD-05-032
10/05

EDDY CURRENT SCANNING REPORT

FNAL-3RDHARMONIC CAVITIES #3-6

FNAL/Technical Division

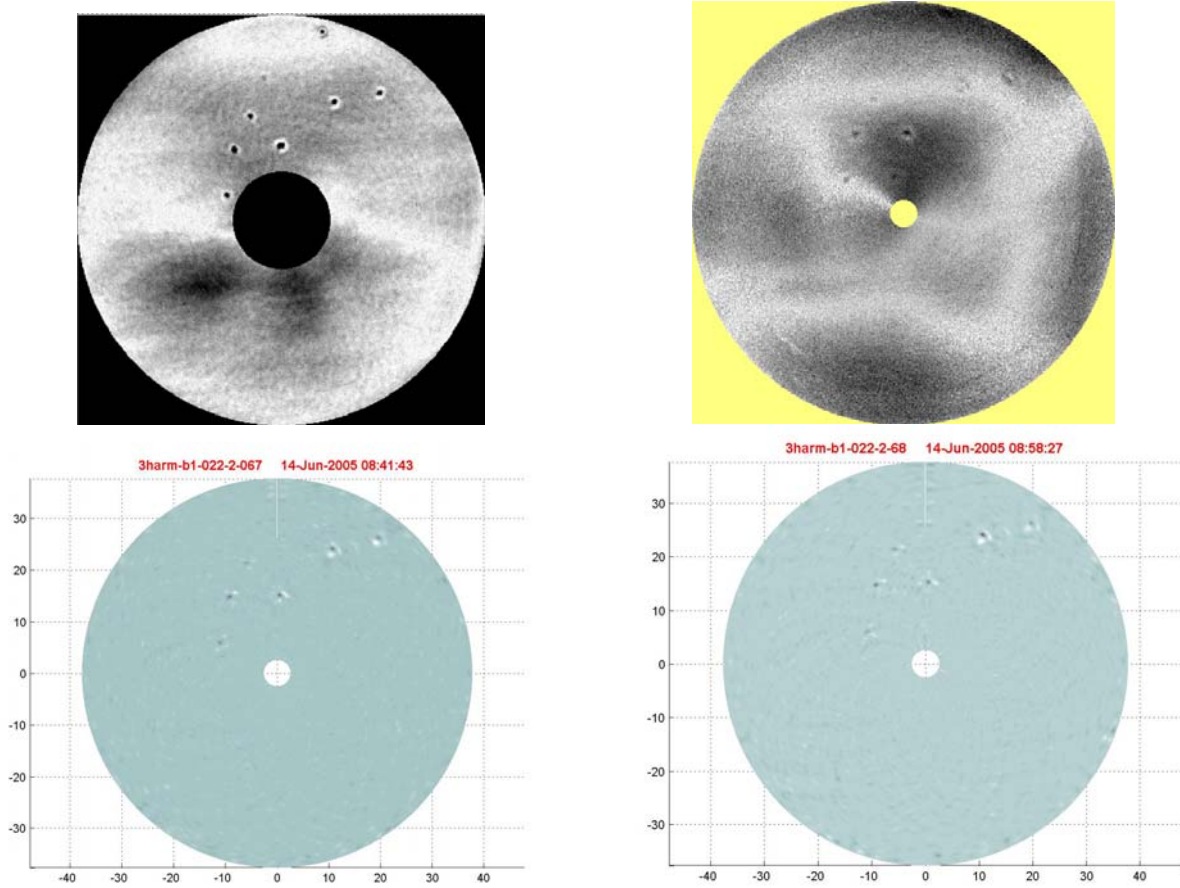
⁴ 3rd harmonic – batch 1 – disc 22- side 2 is the disc shows several strong signals in the DESY and FNAL scans and is therefore used as reference.

Figure 2: Example of eddy current scans performed on a niobium disc for Fermilab's 3rd harmonic cavity with the DESY scanner (top left) and SNS/FNAL scanner (top right and left & right bottom). The bottom two scans were obtained after the measurement campaign reported here, the one on top right, before.

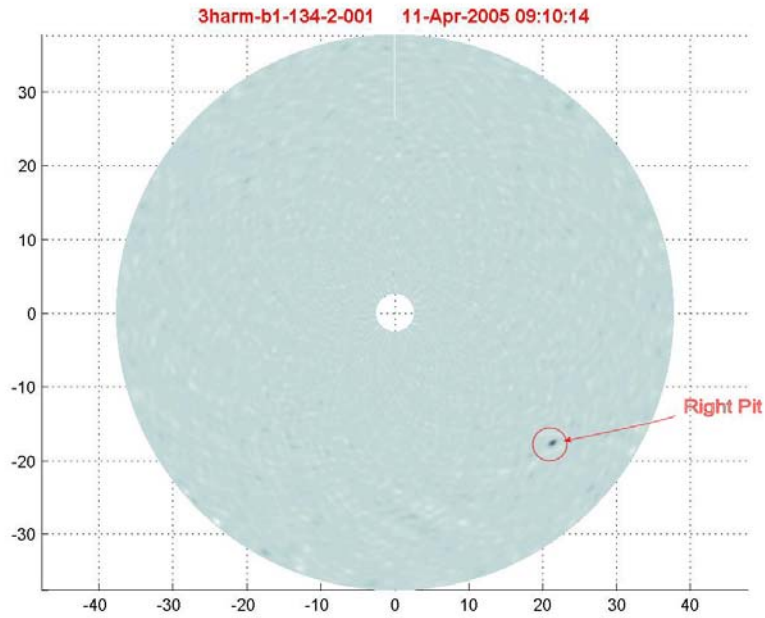
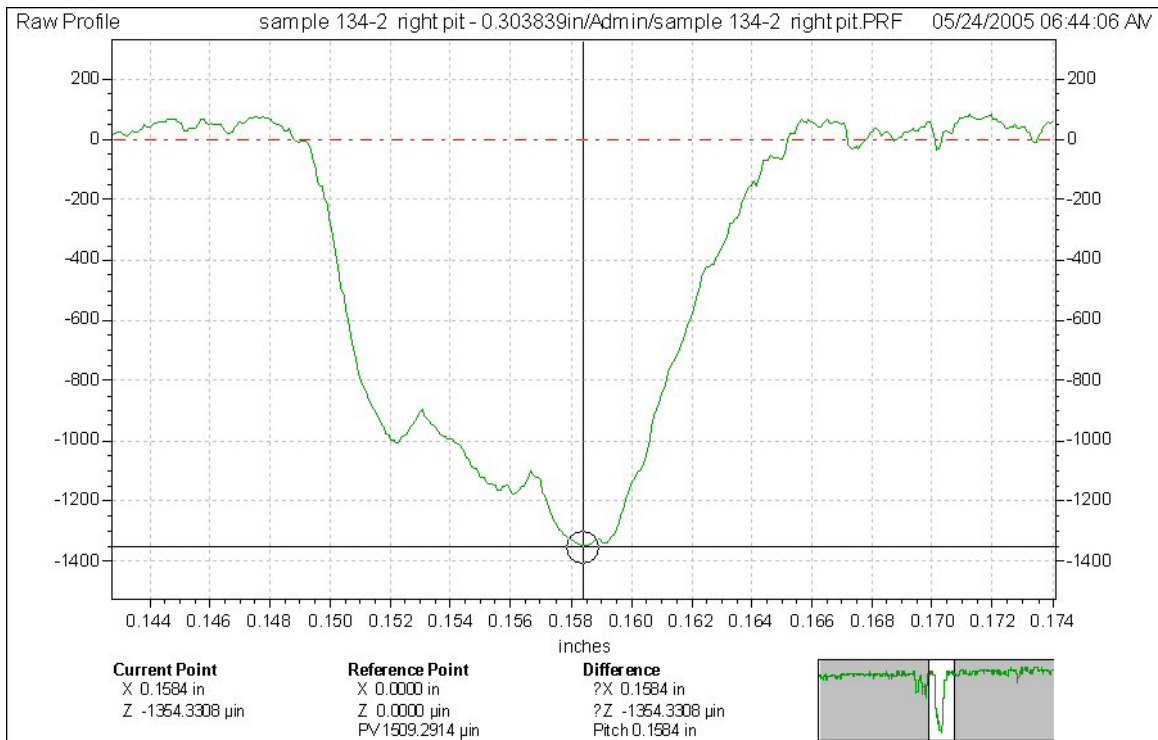
Pit location

Profilometric measurements were performed on discs 134, 135, 144, 148, 149 and 150 to estimate the depth of the etching pits. These pits vary from 0.2 to 0.5 mm in width and from 10-90 microns in depth. Appendix 1 lists the sum of the data. These profiles would indicate that subsequent etching of ~120 microns would remove them, such as was found in one case in the previous study (in the other case such an etch was not sufficient). The so called “roller-marks” did not give any measurable profile (our equipment for profilometric measurement might not be capable of detecting long range effects, however).
